# Your Inspection Report

123 Example Dr  
Ottawa, ON A1B 2C3

**INSPECTION DATE:**  
Monday, January 1, 2024

Atlas Peak Inspections  
123 example St  
Ottawa, ON A1B 2C3

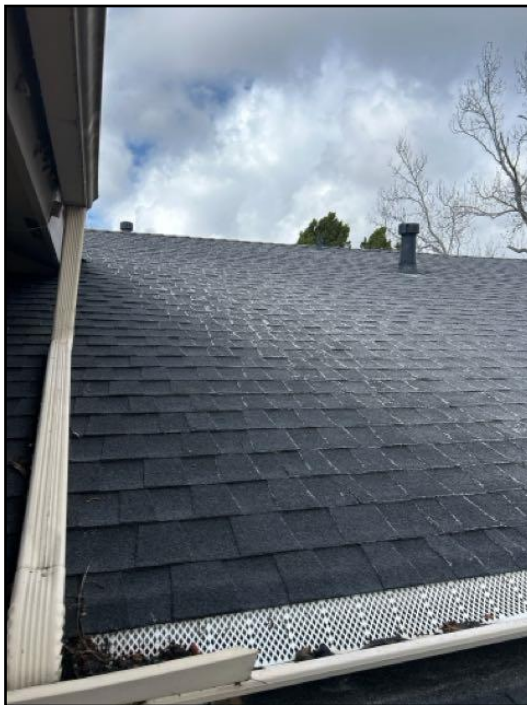
3. **Condition:** • Granule loss

**Implication(s):** Chance of water damage to structure, finishes and contents

1. Granule loss

**Task:** Replace

**Time:** Less than 1 year

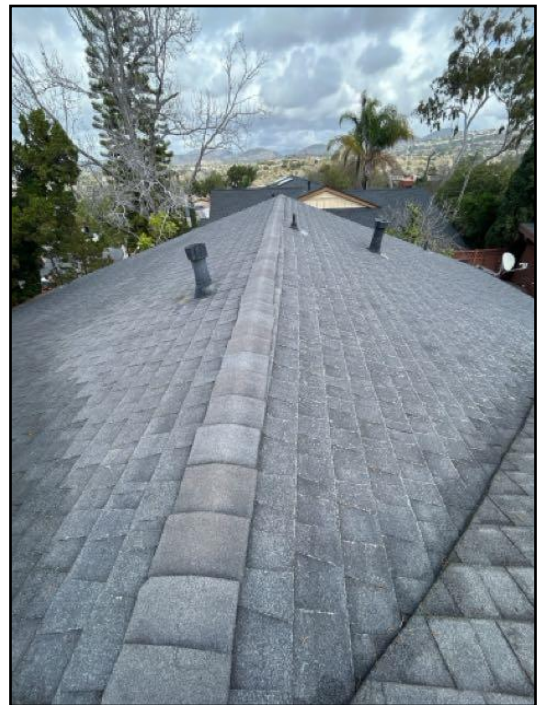
2. Granule loss

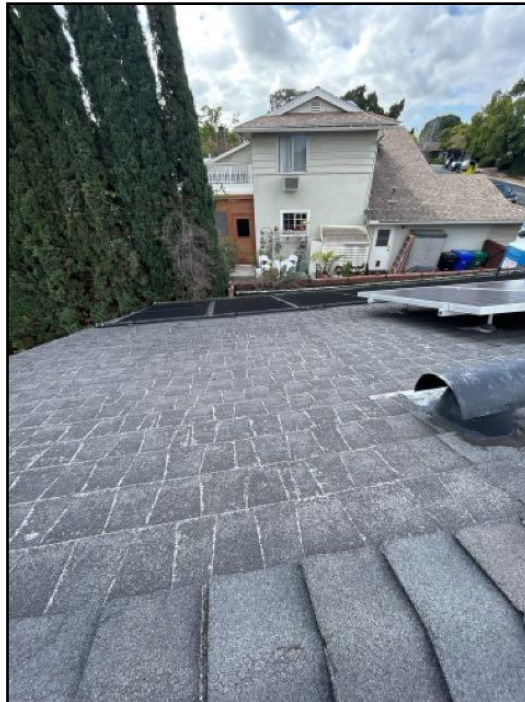
3. Granule loss

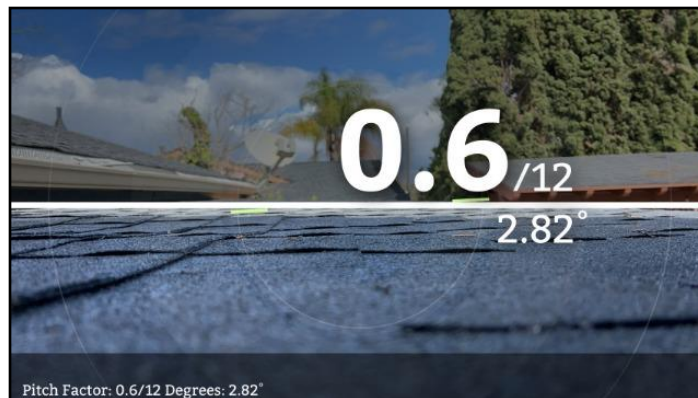
**4. Condition:** • Slope too low

**Implication(s):** Chance of water damage to structure, finishes and contents

4. Slope too low

Replace the shingles with rolled roofing due to ponding and ice damming potential with the low slope. Asphalt shingles should be installed with 4/12 slopes or higher.

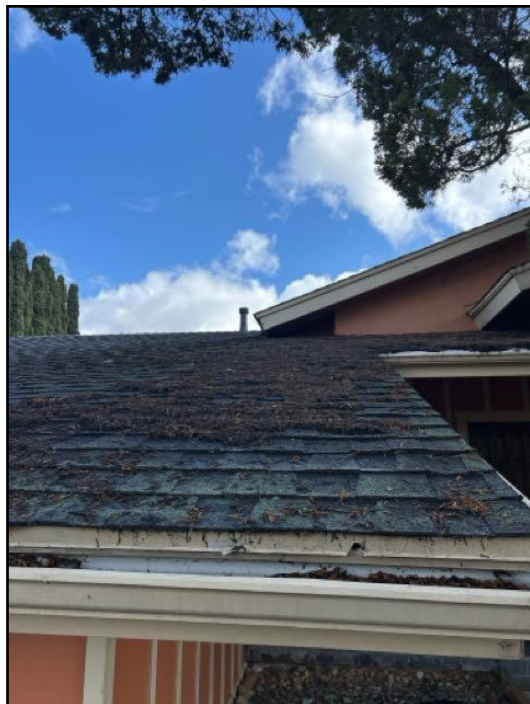
**5. Condition:** • Debris/moss

**Implication(s):** Shortened life expectancy of material

5. Debris/moss

When new roof is laid inspect and maintain the area quarterly to prolong the life of the shingles.

**Task:** Clean

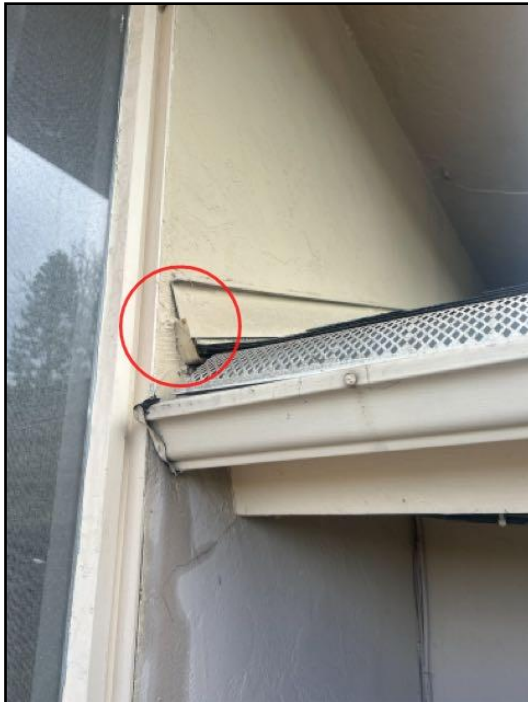
**6. Condition:** • Kickout flashing - missing

To small not doing enough to divert water away from wall. Signs of water spilling onto stucco below

7. Kickout flashing - missing

**Task:** Replace

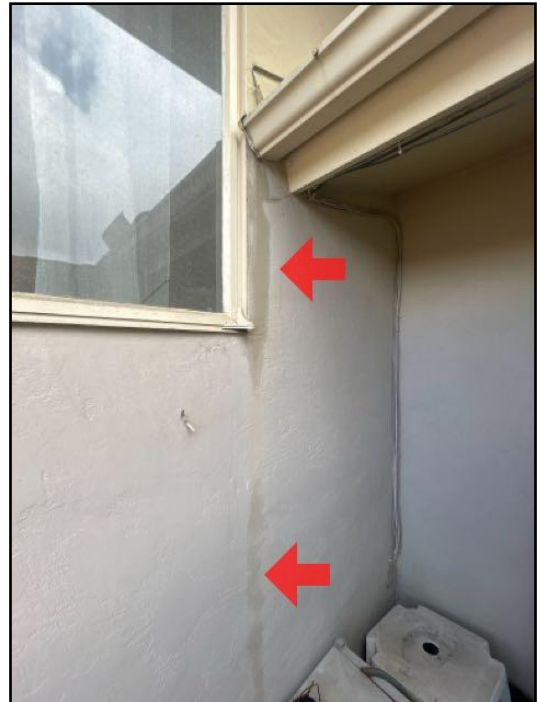
8. Signs of water damage

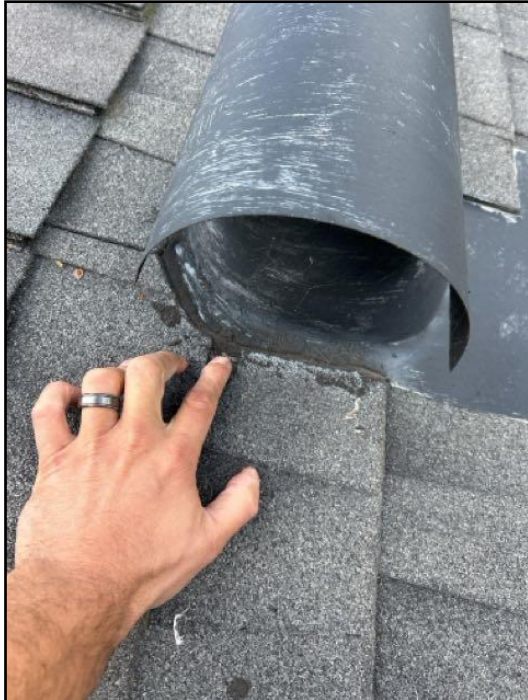
9. caulking has deteriorated

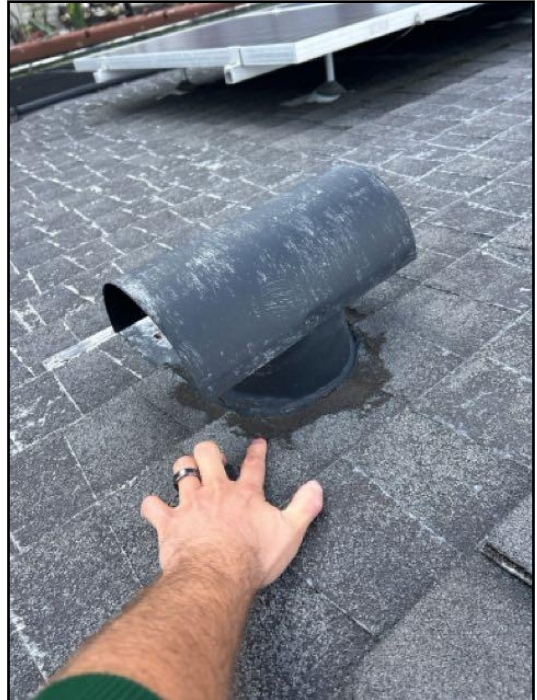
10. caulking has deteriorated

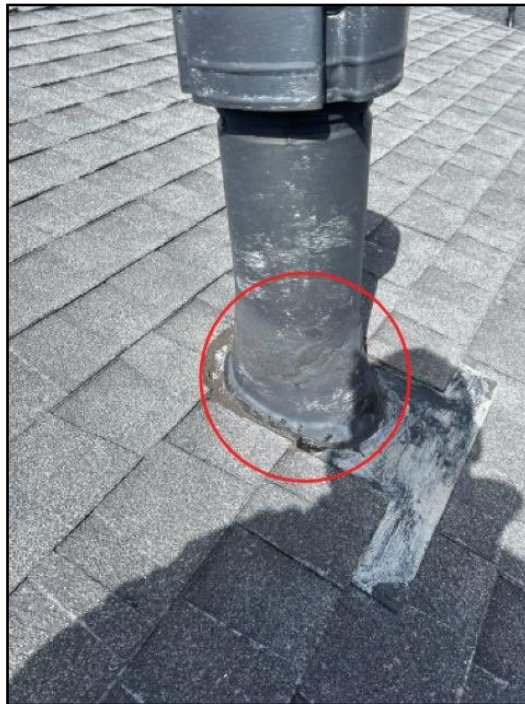
11. caulking has deteriorated

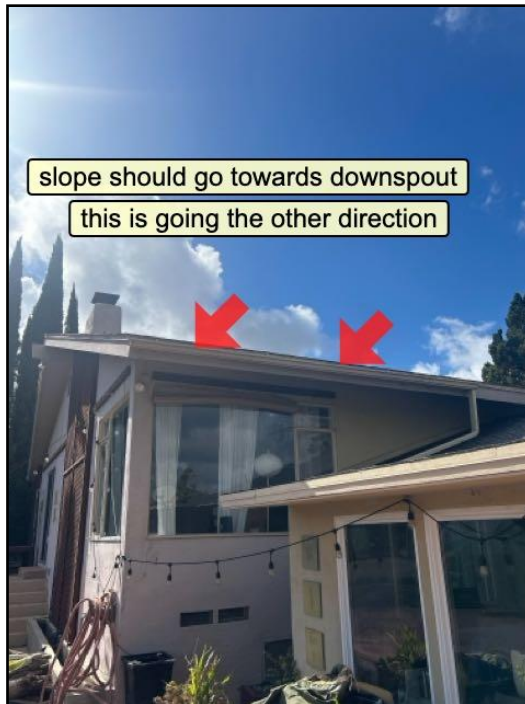
**8. Condition:** • Improper slope, ponding

13. Improper slope

Recommend replacing all gutters. Recommend using screen on gutters where lots of tree debris accumulates. Monitor the Yankee gutter at bottom corner of backyard roof.

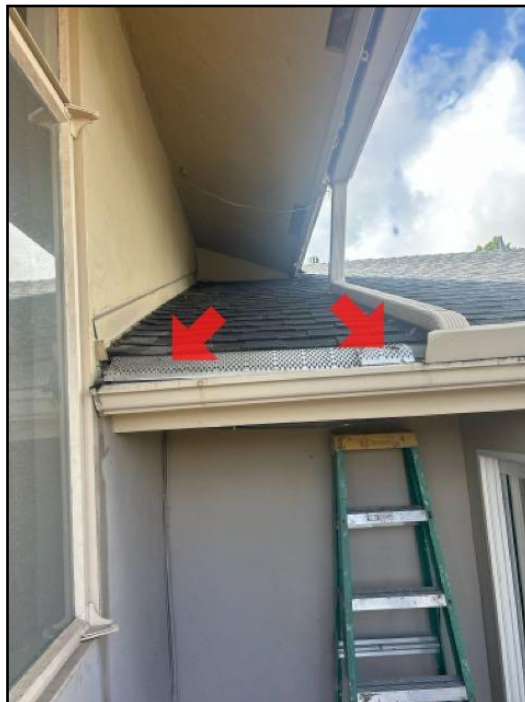
**9. Condition:** • Loose

14. Loose leaf guard along the gutter

**Task:** Repair or replace

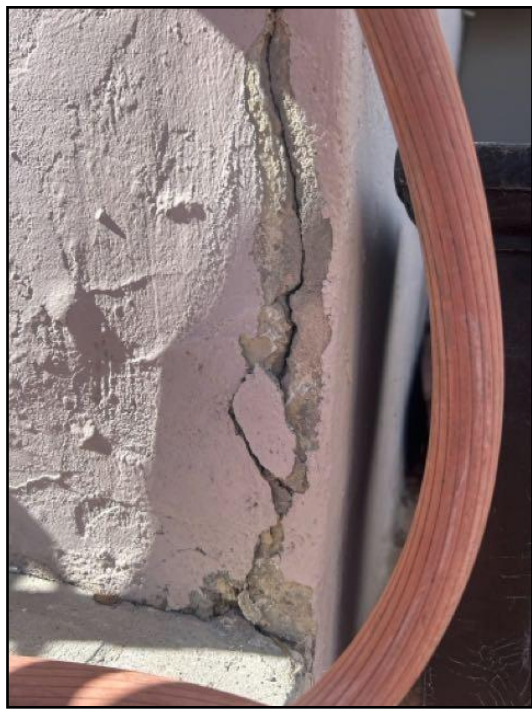
Structural cracks at multiple points along the rear wall of the house.

15. large crack

**Task:** Further evaluation by Structural engineer

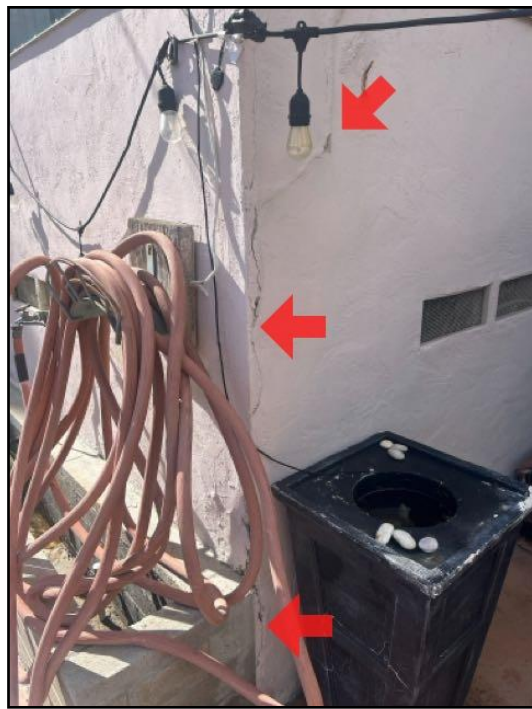
16. large crack along corner

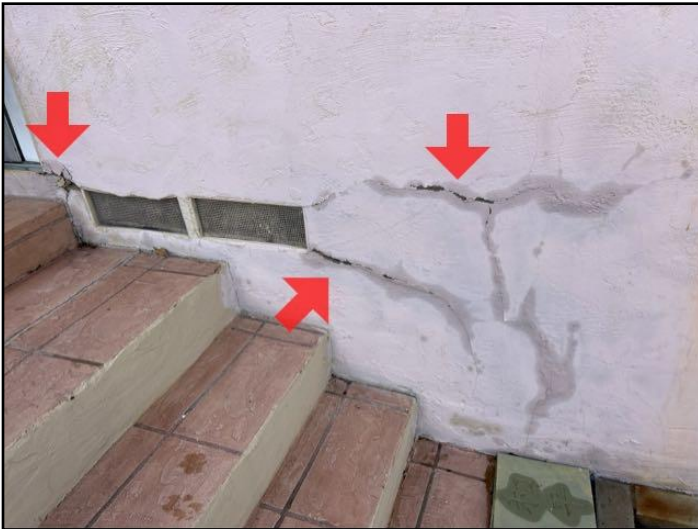
17. multiple cracks

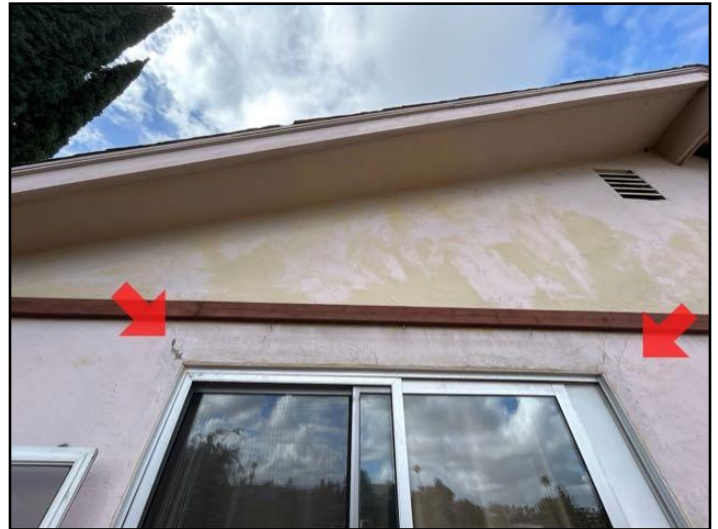
18. cracks at corner of door

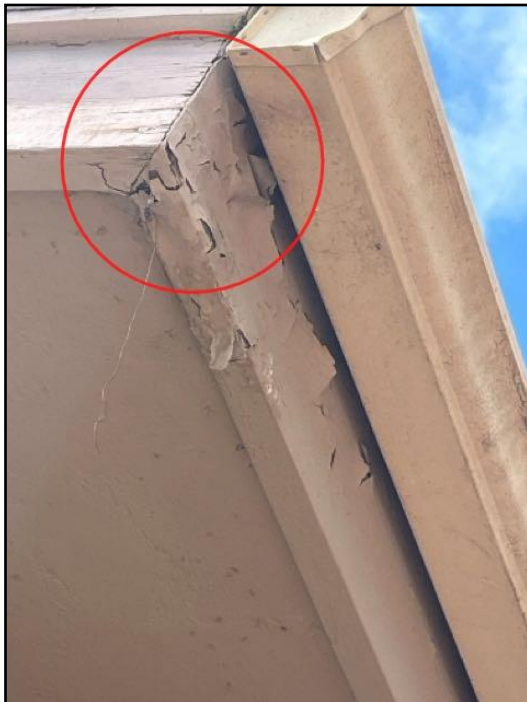
**13. Condition:** • Paint - deteriorated / missing

19. Paint has deteriorated will lead to rotten wood

The second picture shows signs of a lot of water flowing from the other roof. Further evaluation by a qualified roofing contractor.

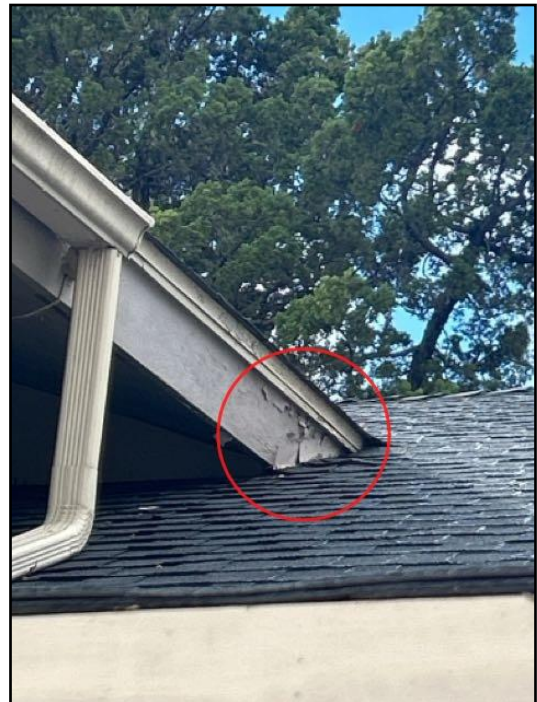
20. Paint deteriorated will lead to rotten wood

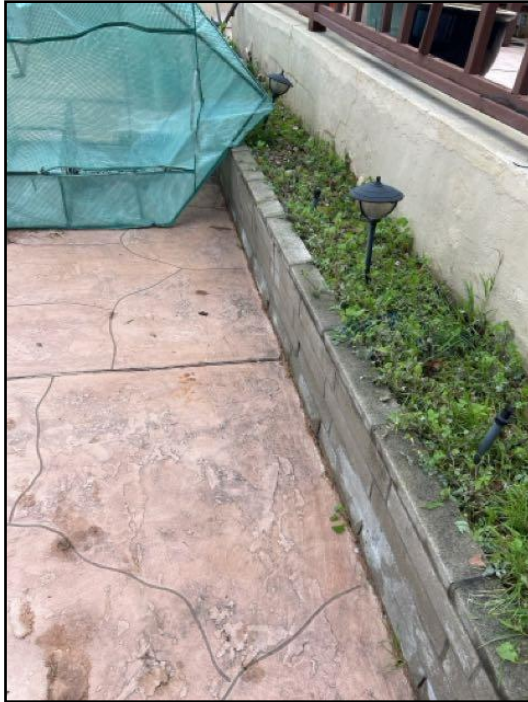
**14. Condition:** • Bowing walls

Flower bed may fall due to hydrostatic pressure and poor material used to build a retaining wall.

21. Bowing walls

**Task:** Monitor

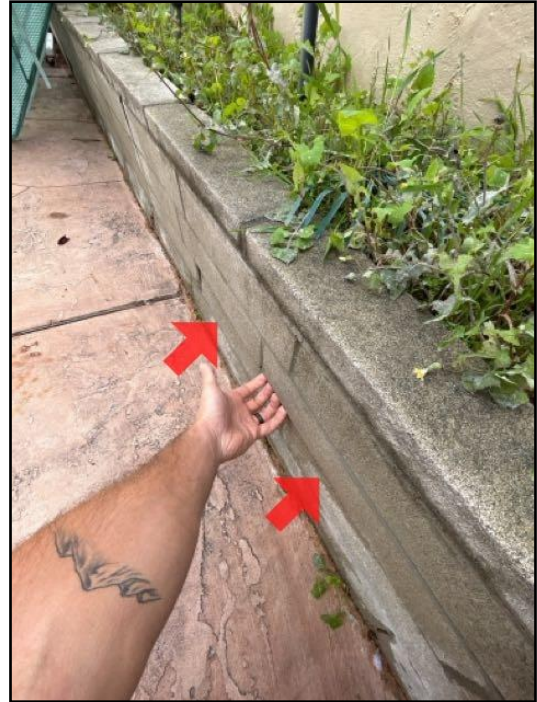
22. Top half is bowing out

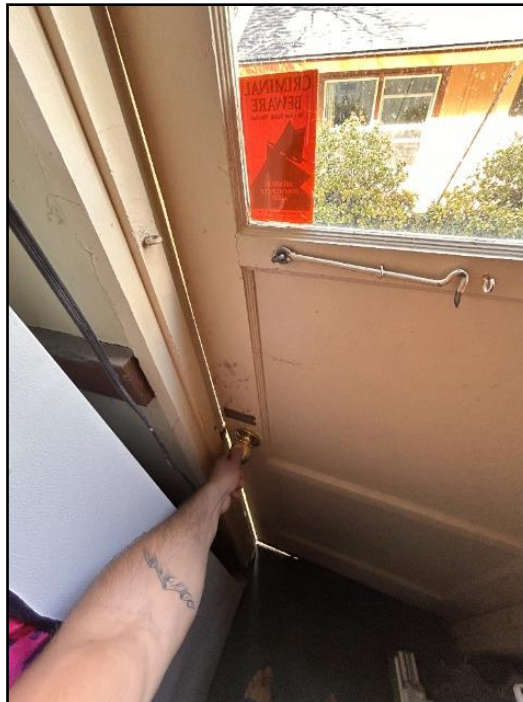
**18. Condition:** • Swings open or closed by itself

If not closed tightly the door will open by itself, if pushed or pulled lightly it will open. This is a safety concern because it gives access to your garage to anyone.

*23. Swings open by itself*

**Task:** Repair

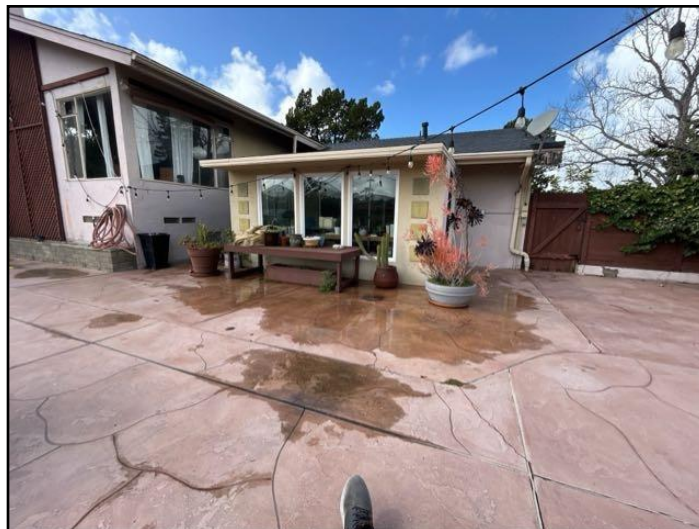
**20. Condition:** • Improper slope or drainage

Previous rain shows water ponding around the sunroom. This could lead to exterior wall rotting and molding if not corrected. Should slope away from home.

25. Towards building

**Task:** Further evaluation by landscaping contractor

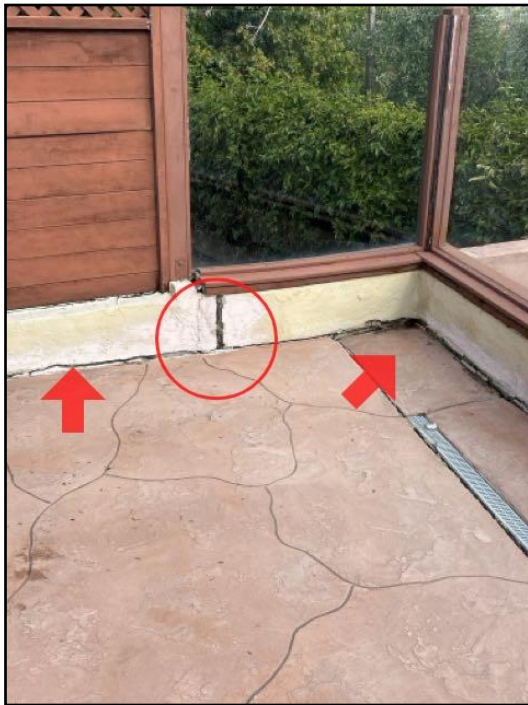
**21. Condition:** • Cracked

Excessive cracks at multiple location along the back.

26. Crackes and slopping away

Task: Further evaluation by landscaping contractor

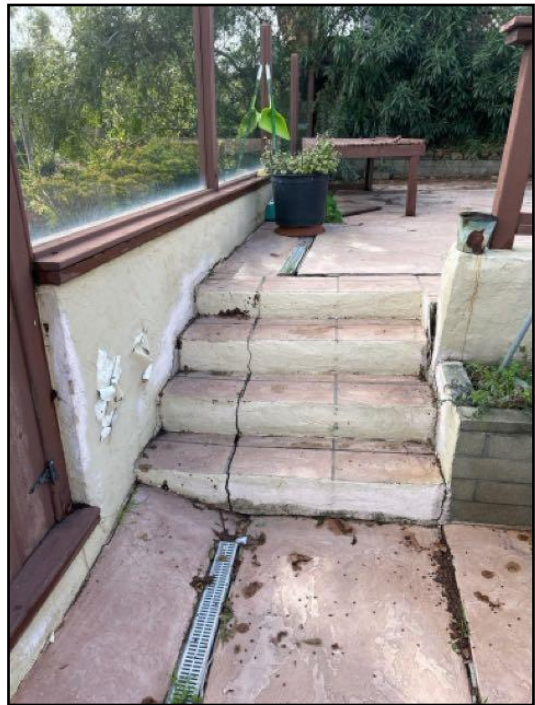
27. large crack

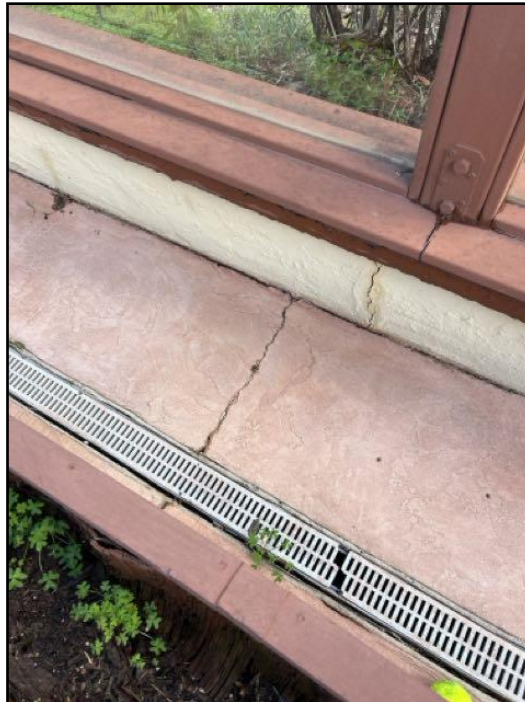
28. Cracked

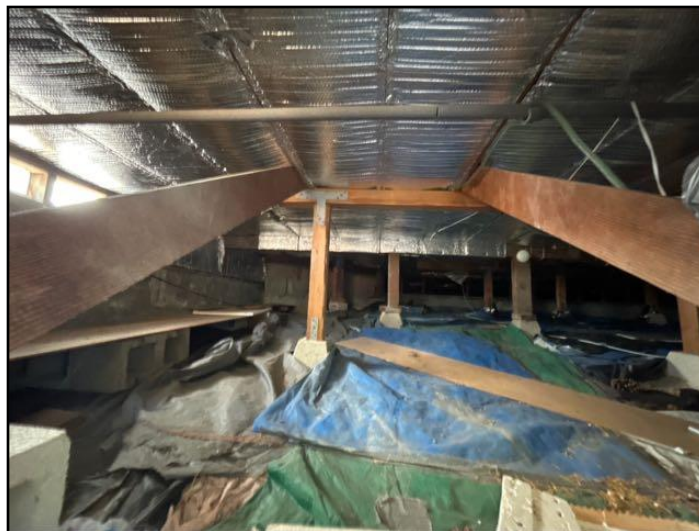
Insulation covered the walls and under floor ceilings.

**30.** *Entered but access was limited*

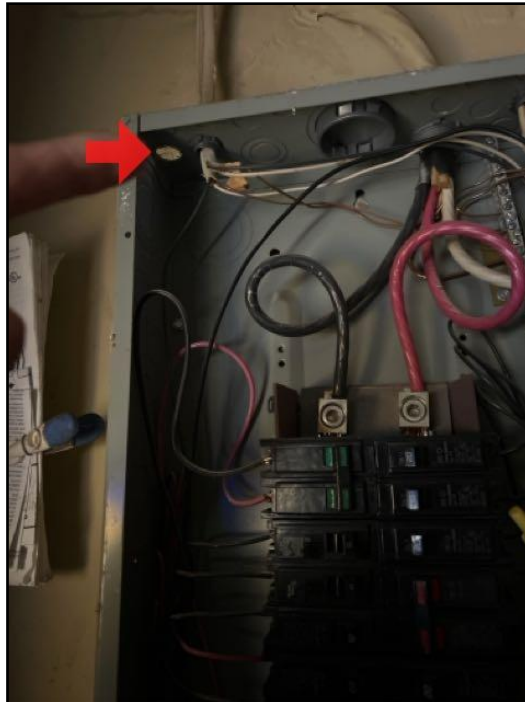
**25. Condition:** • Damaged panel or components

Knockout on top left of panel is left open. Possible shock or faulty electrical hazard if left unattended.

31. hole could allow water to enter

**Task:** Further evaluation by qualified electrician

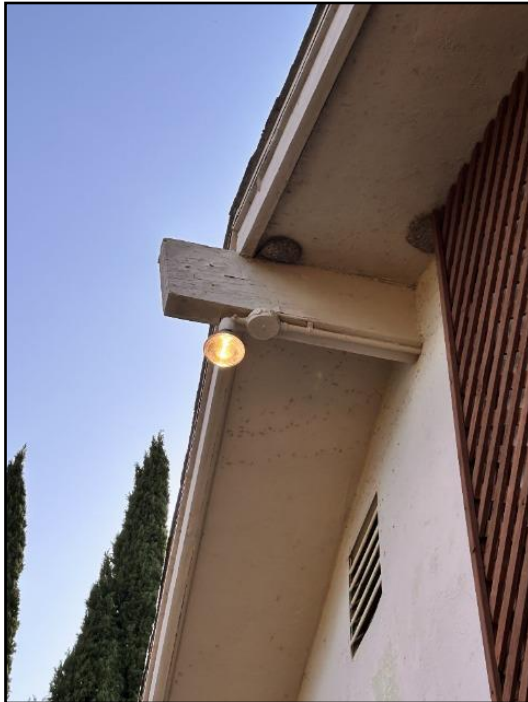
Exterior flood lights. 3 of the 4 switches at the receptacle are inoperative. Further evaluation by a licensed electrician.

33. *operative far right switch*

**Task:** Repair

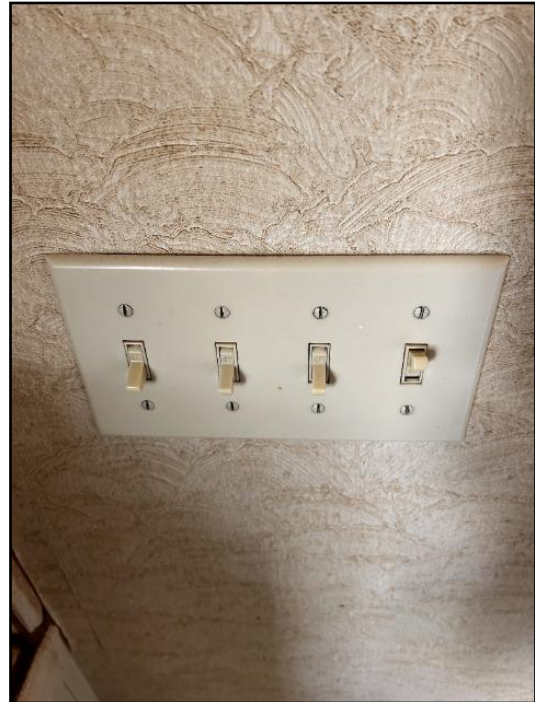
34. *3 left switches are Inoperative*

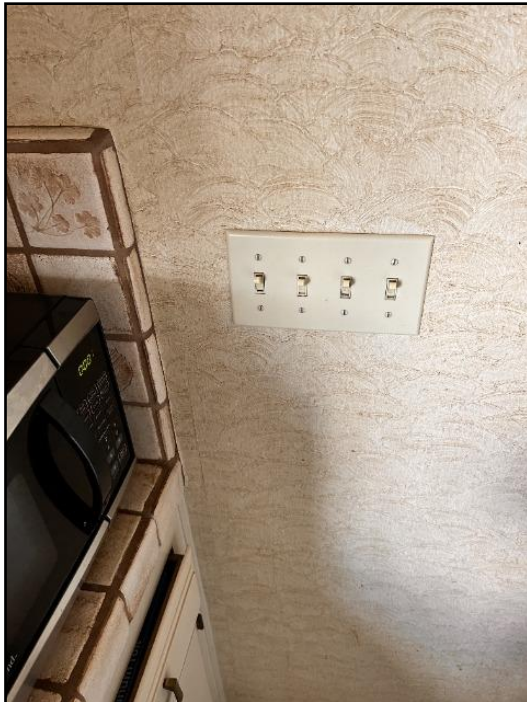
35. all switches turned on

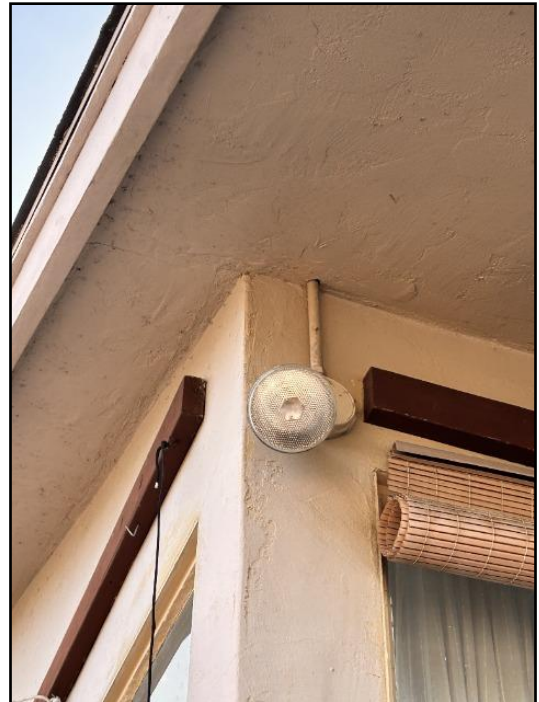
36. Flood light Inoperative

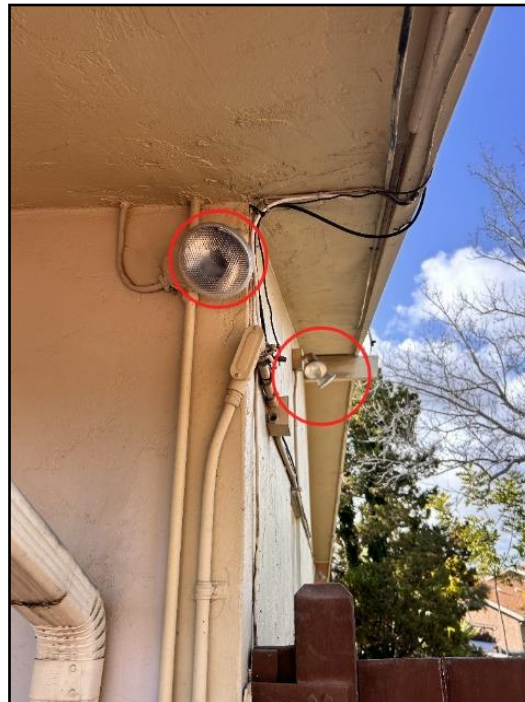
37. 2 flood lights Inoperative

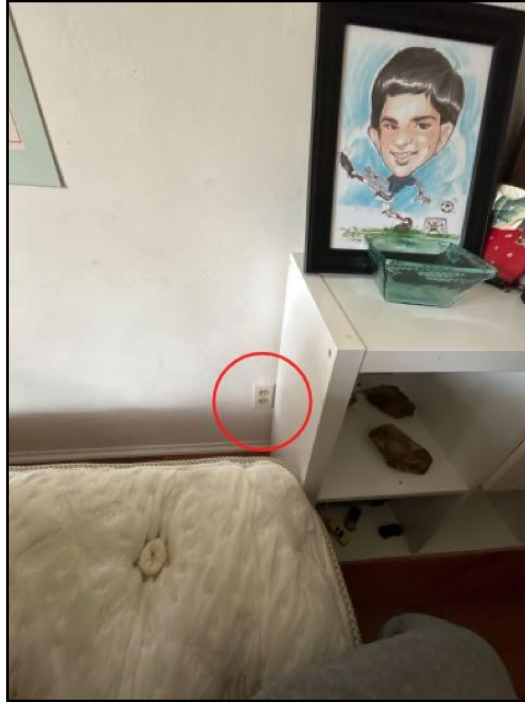
**28. Condition:** • Ungrounded

Outlet does have ground wire. Will not protect devices from electrical surge and also potential shock hazard.

**38.** *Ungrounded outlet*

**Task:** Replace

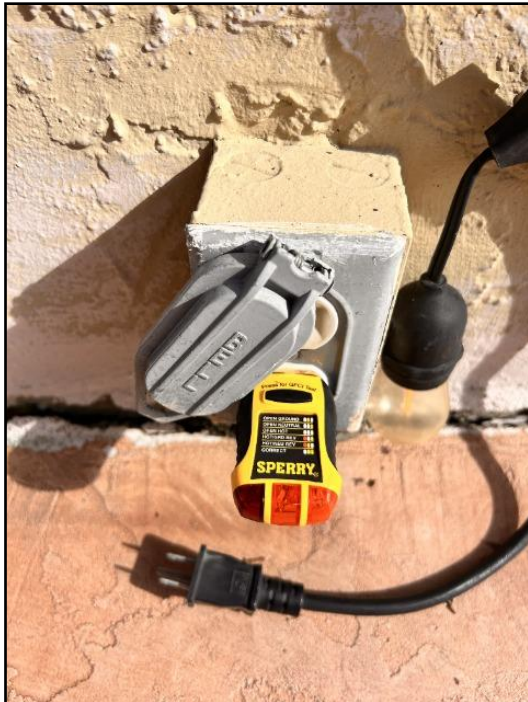
**29. Condition:** • Not suitable for outdoor (exterior) use

39. Not suitable for outdoor (exterior) use

Exterior receptacles should have properly working covers.

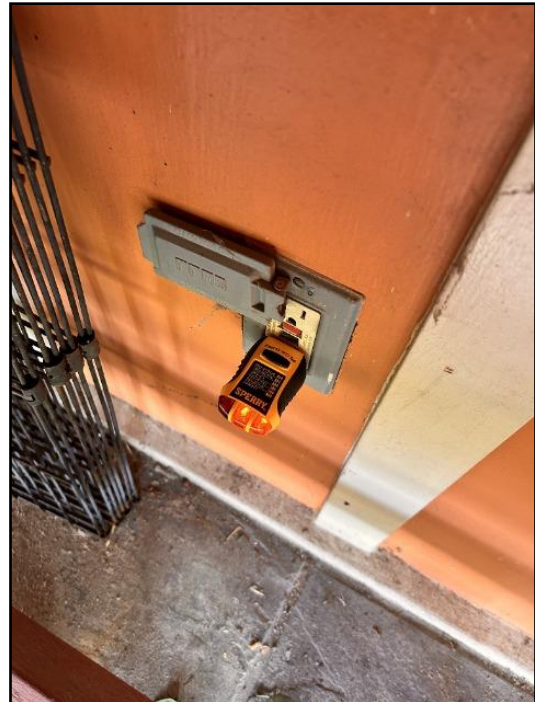
40. Not suitable for outdoor (exterior) use

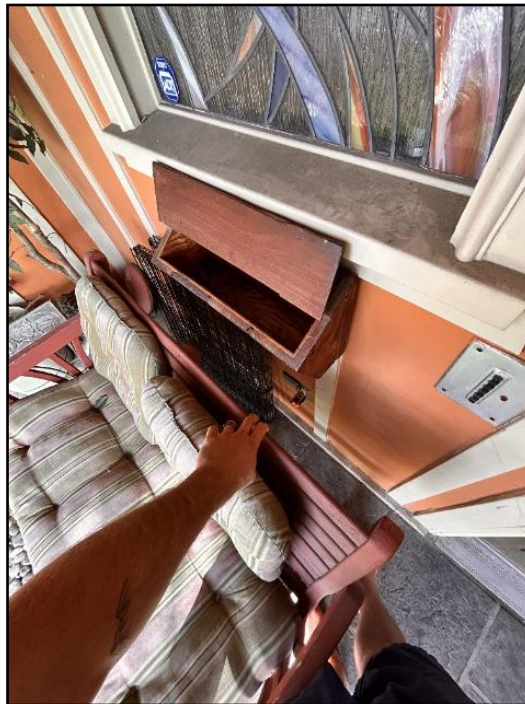
41. Not suitable for outdoor (exterior) use

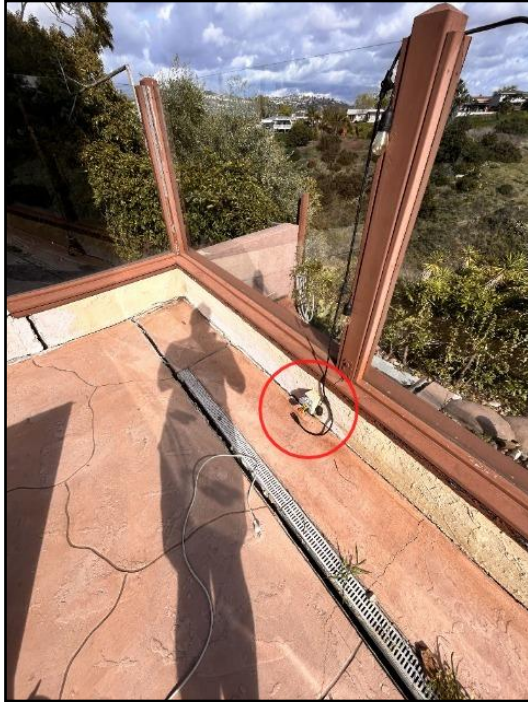
**30. Condition:** • GFCI/GFI needed (Ground Fault Circuit Interrupter)

42. GFCI needed at exterior

Further evaluation by a licensed electrician.

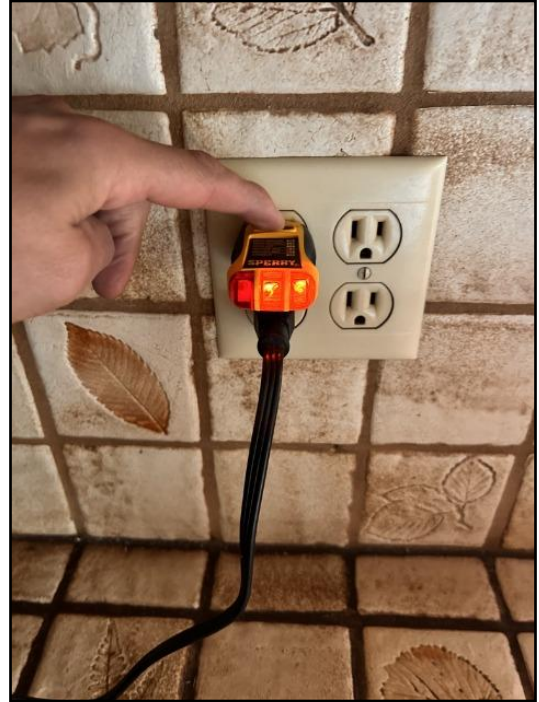
43. GFCI in kitchen

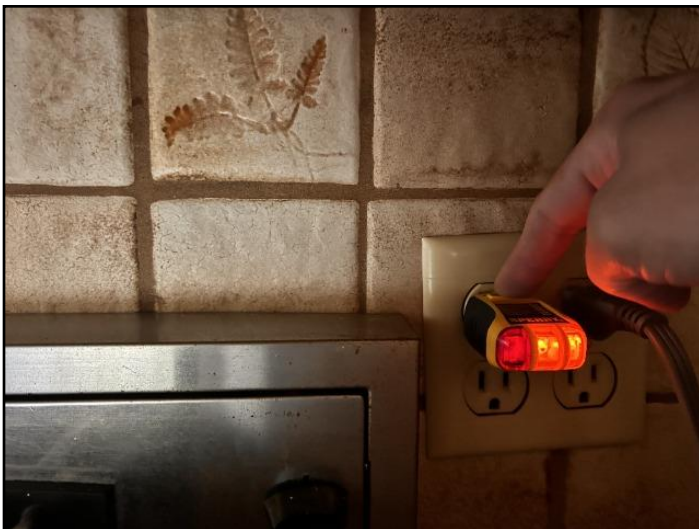
44. GFCI needed in kitchen

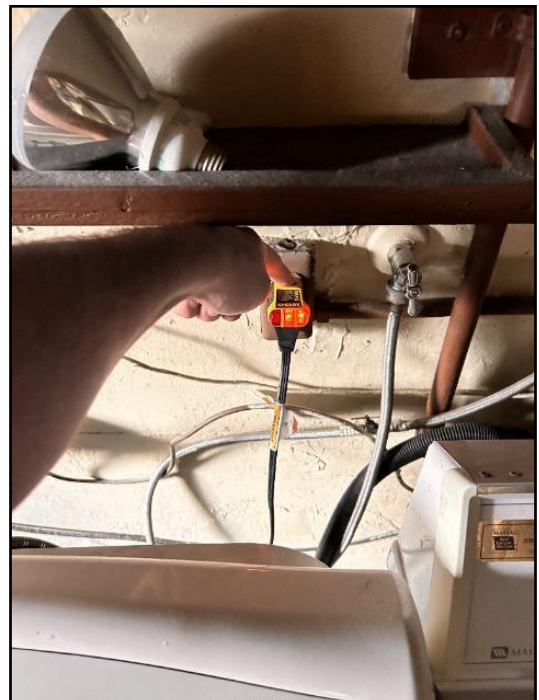
45. GFCI needed behind washing machine

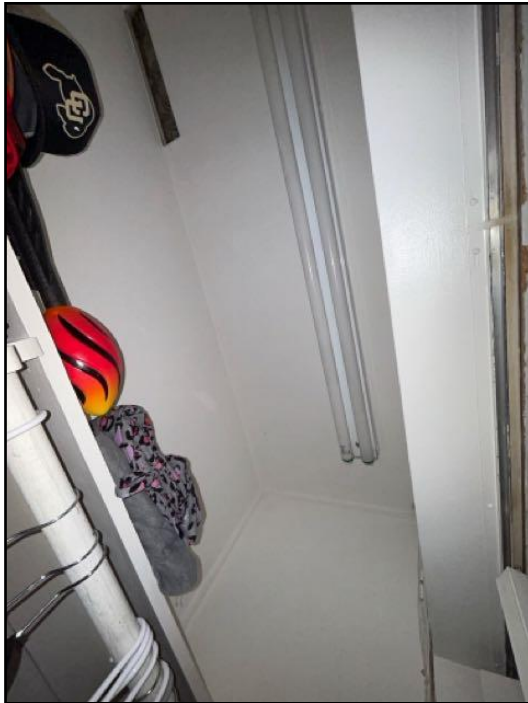
**32. Condition:** • Improper closet lighting

Safety defect. Possible electrical shock and other harm from fluorescent lights if broken.

46. Improper closet lighting

**Task:** Replace

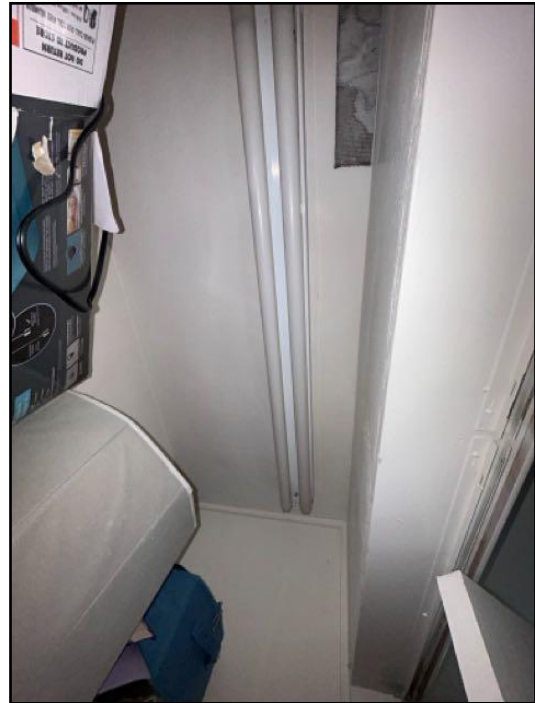
47. Improper closet lighting

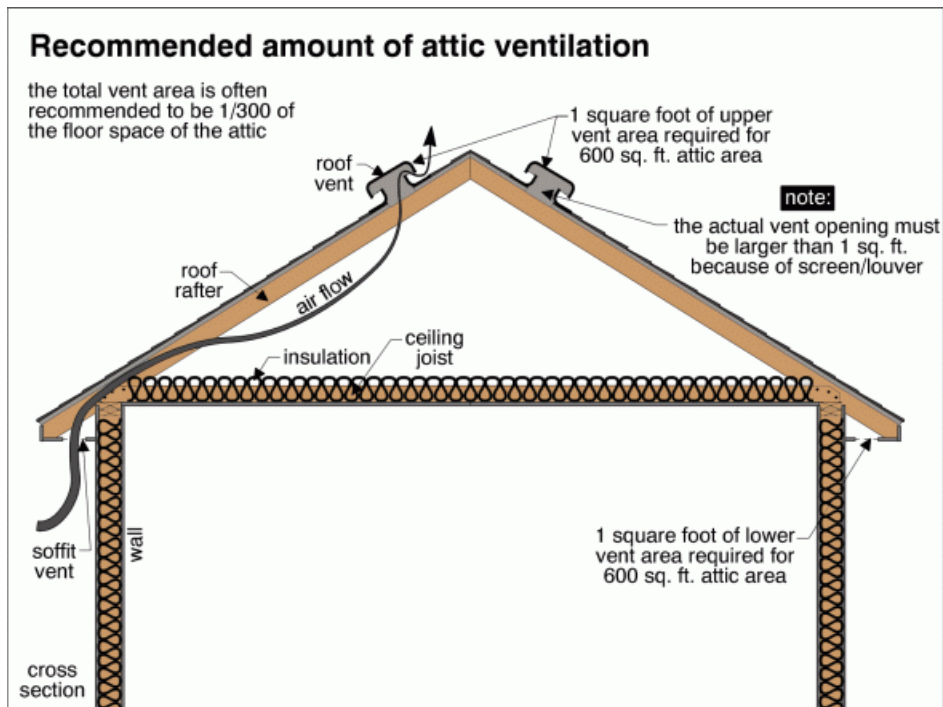
**39. Condition:** • Inadequate

Not enough ventilation at both soffit and on roof. Recommend using ridge vents.

**Task:** Further evaluation by a qualified Roofer

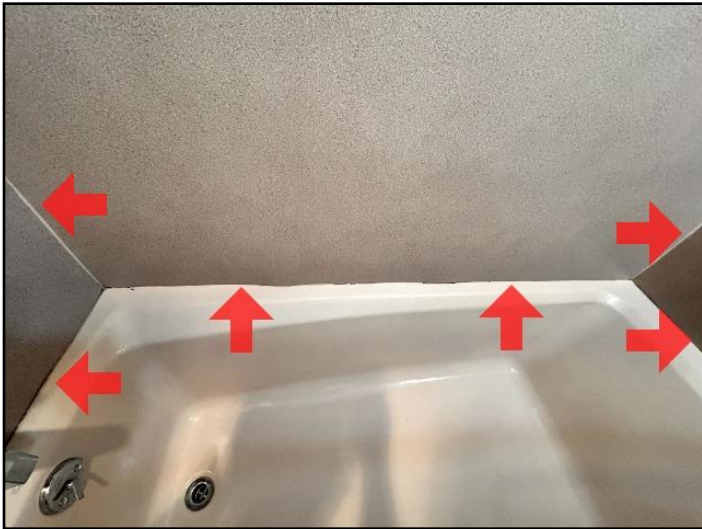
**40. Condition:** • Caulking loose, missing or deteriorated

49. Caulking deteriorated

**Task:** Repair or replace

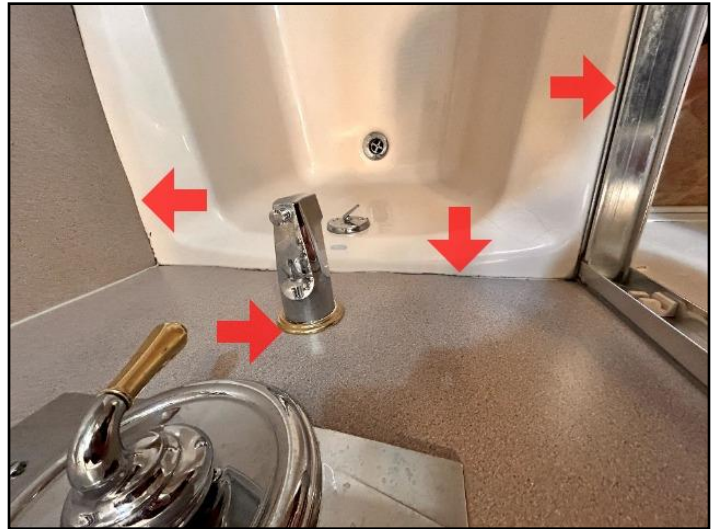
50. Caulking deteriorated

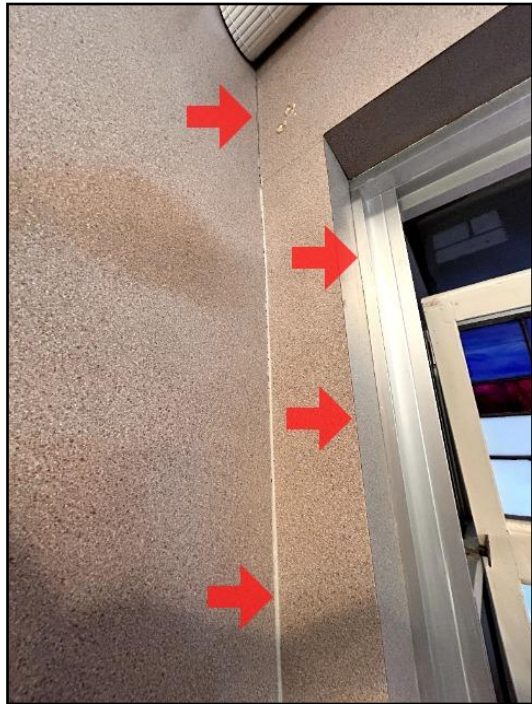
51. Caulking deteriorated

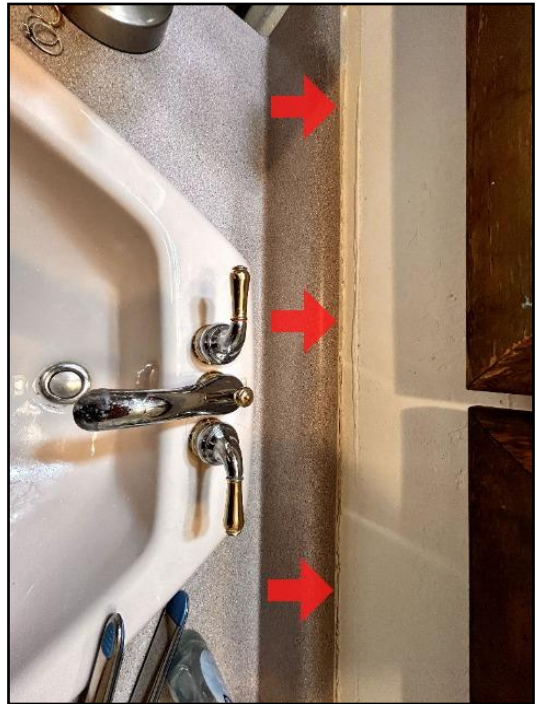
52. Caulking deteriorated

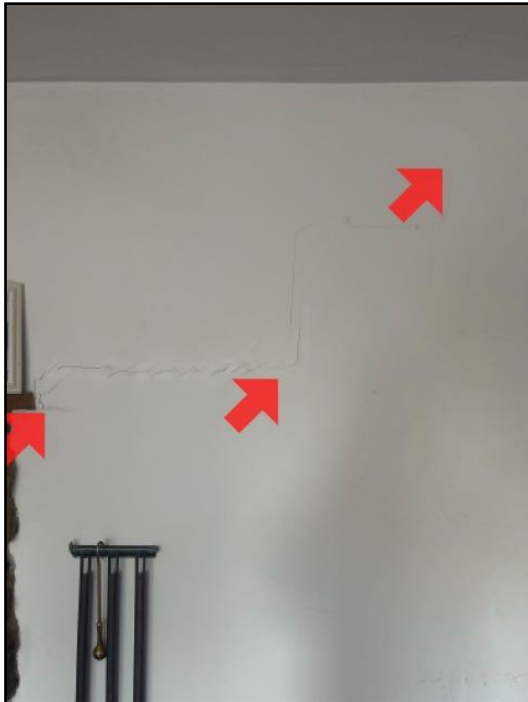
**41. Condition:** • Cracked

Could be related to exterior backyard cracks.

53. large staggering crack

**Task:** Recommend further evaluation by structural engineer

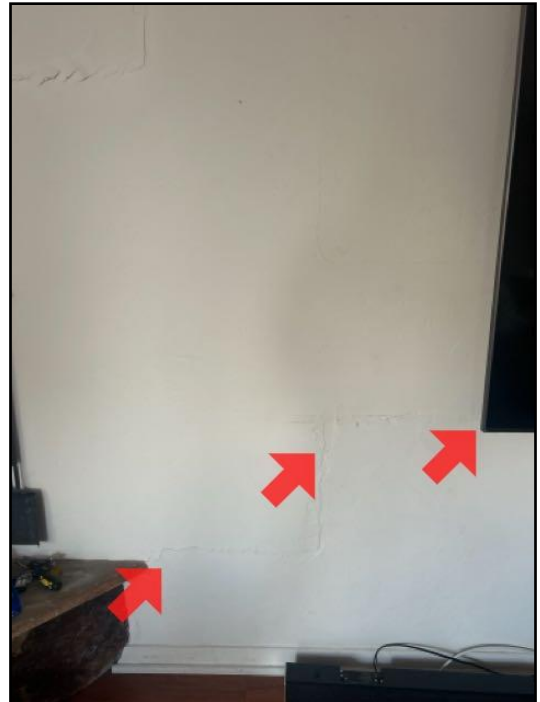
54. Second staggered cracked

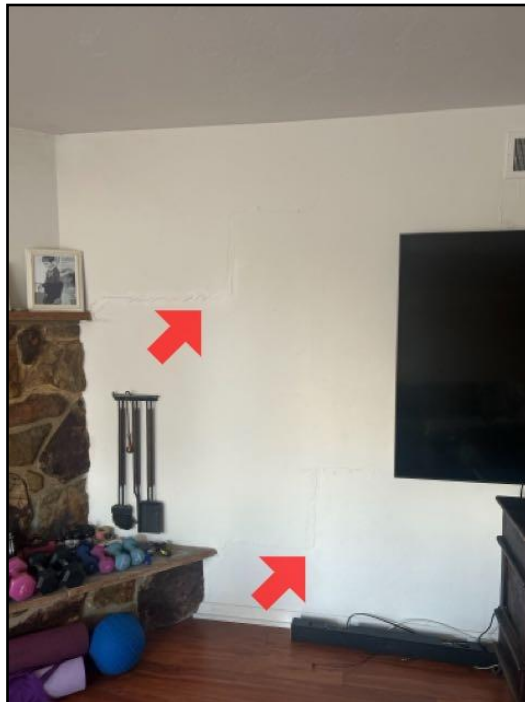
55. Both Cracks

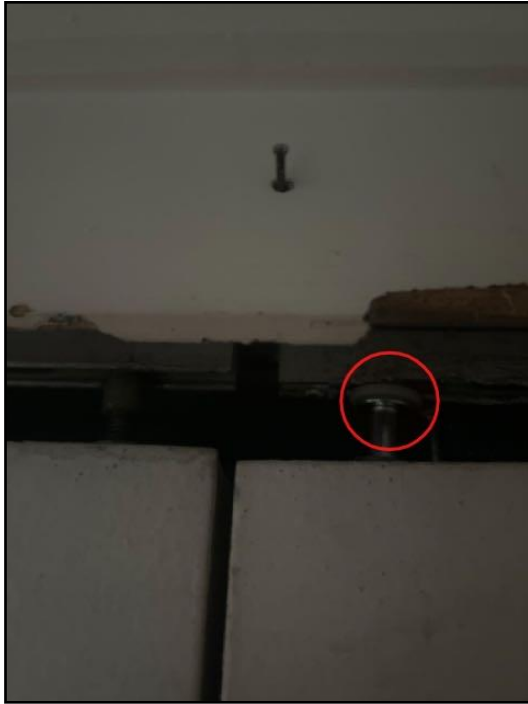
**42. Condition:** • Ineffective

Bifold linen closet doors fall off track and are very worn

56. Ineffective

**Task:** Repair

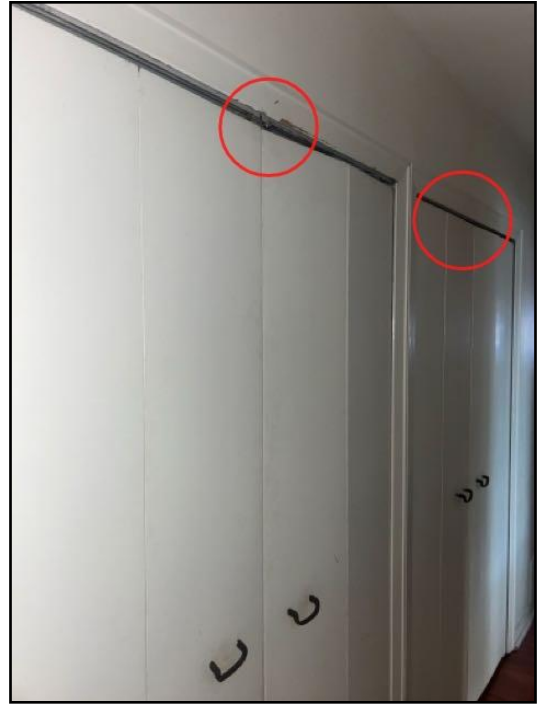
57. Ineffective

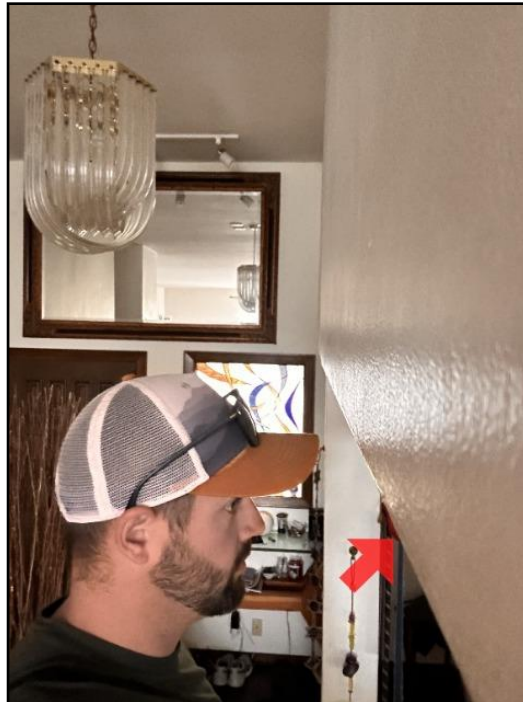
**43. Condition:** • Headroom less than ideal

58. Headroom less than ideal

**Task:** Recommend further evaluation by a framing contractor.

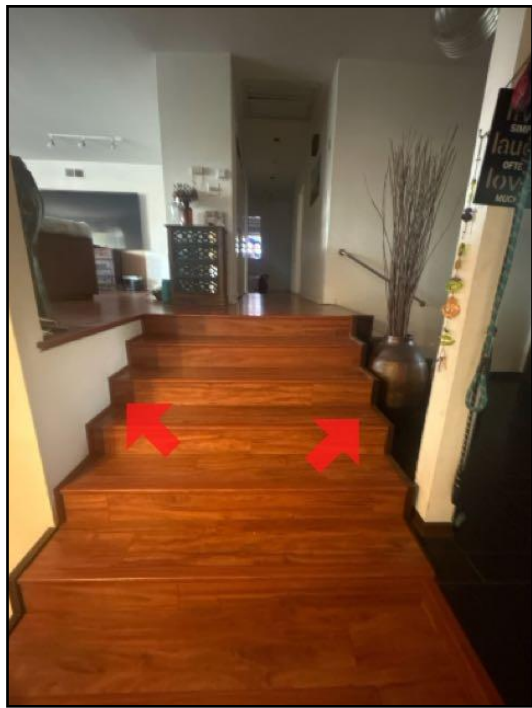
**44. Condition:** • Missing

Tripping and falling hazard with nothing to grip. Recommend installing railing on both sides of each stairs.

59. wide stairs should have rails on both sides

**Task:** Further evaluation by railing contractor

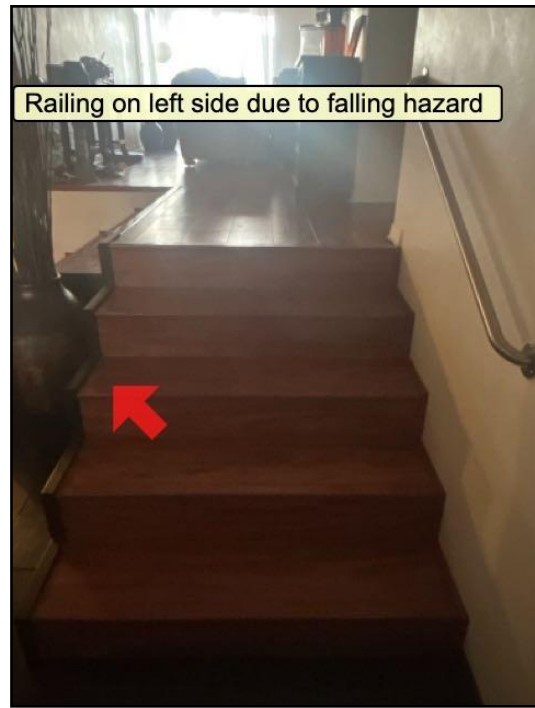
60. Railing needed on left for falling hazard

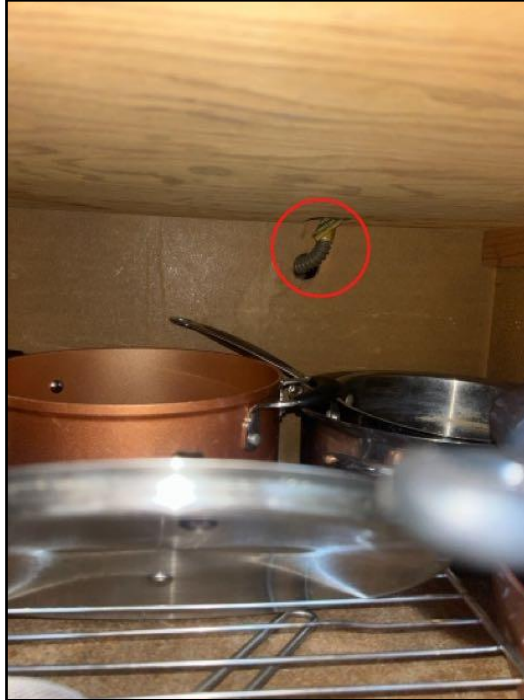
**45. Condition:** • Gas connector passes through wall, floor or ceiling

Needs to be solid piping through walls and cabinets to prevent pipes leaking.

**61.** Gas connector passes through cabinet walls

**Task:** Further evaluation by heating contractor
