# Your Inspection Report

123 Example Dr  
Ottawa, ON A1B 2C3

**INSPECTION DATE:**  
Monday, January 1, 2024

Atlas Peak Inspections  
123 example St  
Ottawa, ON A1B 2C3

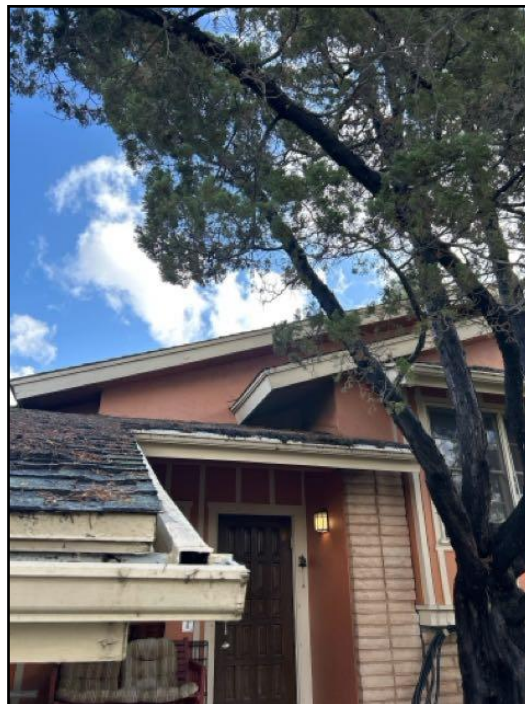
**5. Condition:** • Debris/moss

6. Debris/moss

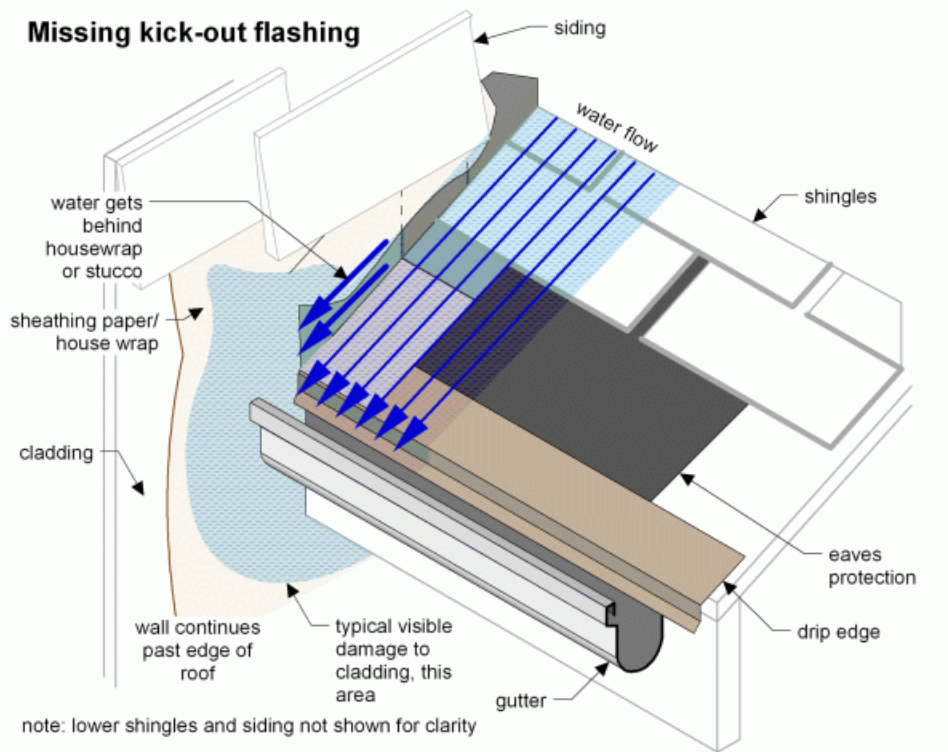
**6. Condition:** • Kickout flashing - missing

**Implication(s):** Chance of water damage to structure, finishes and contents

## Missing kick-out flashing

**Task:** Replace

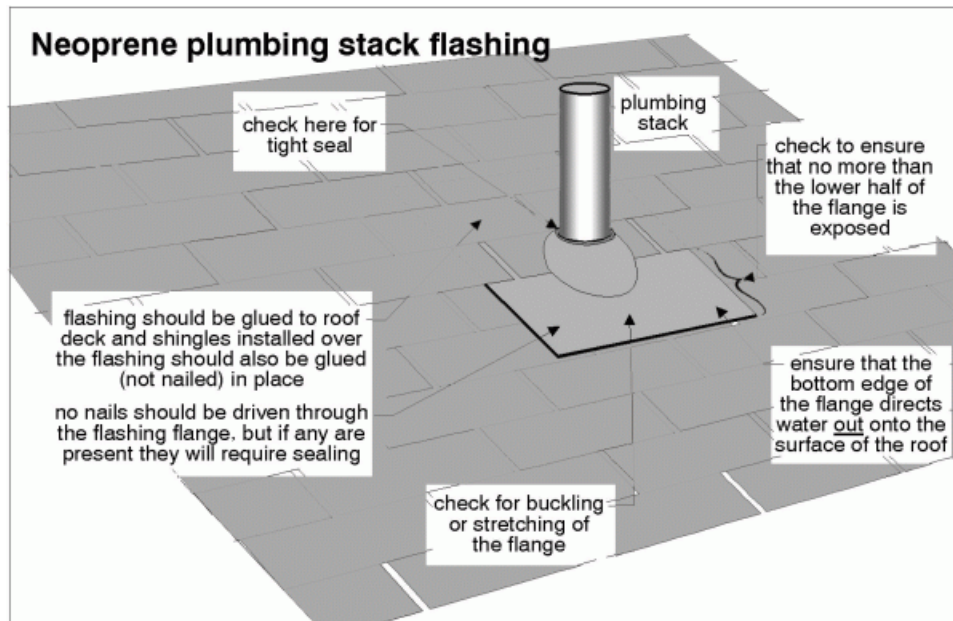
7. **Condition:** • Damage

**Implication(s):** Chance of water damage to structure, finishes and contents

Replace all plumbing stack and gas vent roofing flashing when re-roofing as they are worn out.

**Task:** Replace

**Time:** As soon as possible

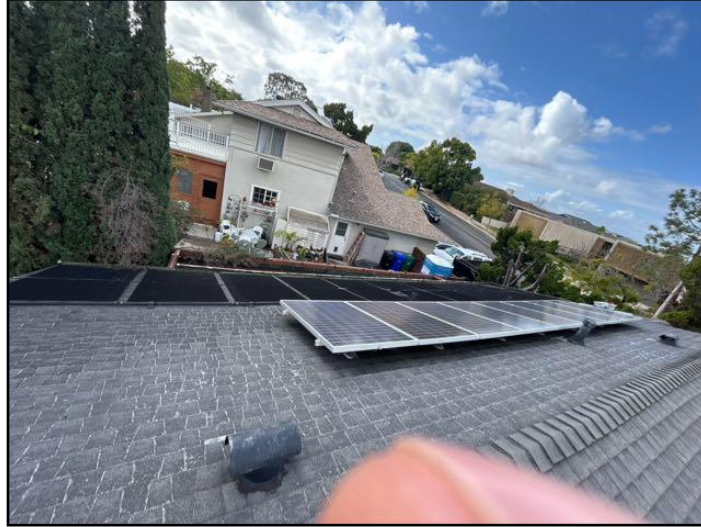
- Solar panels covering roof
- On west side of the home

12. Solar panels covering roof

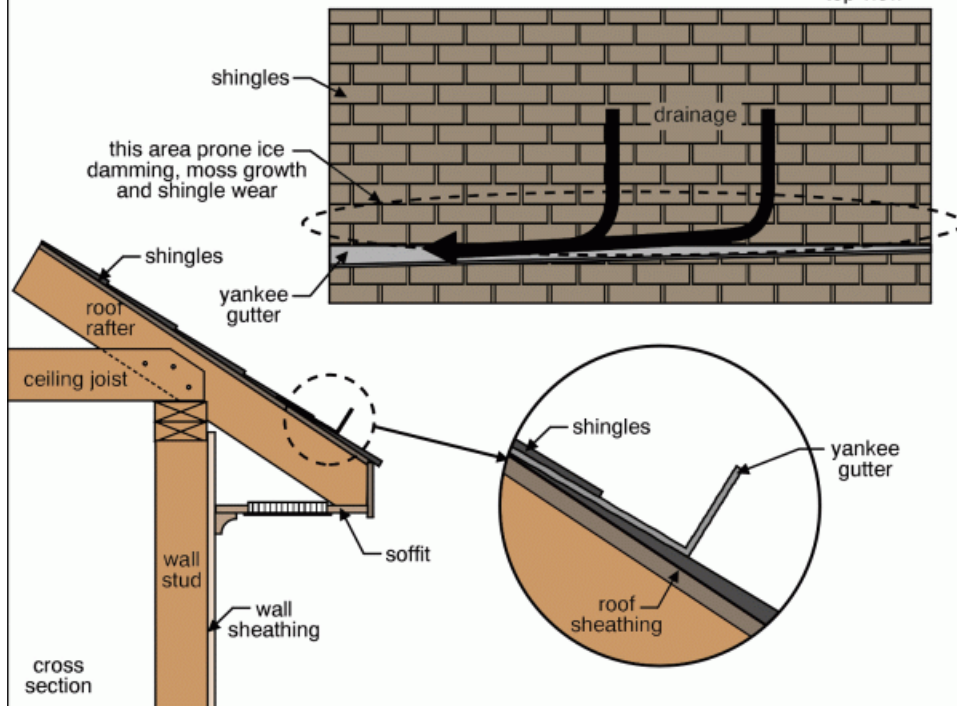
## Yankee gutter

**8. Condition:** • Improper slope, ponding

**Implication(s):** Chance of water damage to structure, finishes and contents

Recommend replacing all gutters. Recommend using screen on gutters where lots of tree debris accumulates. Monitor the Yankee gutter at bottom corner of backyard roof.

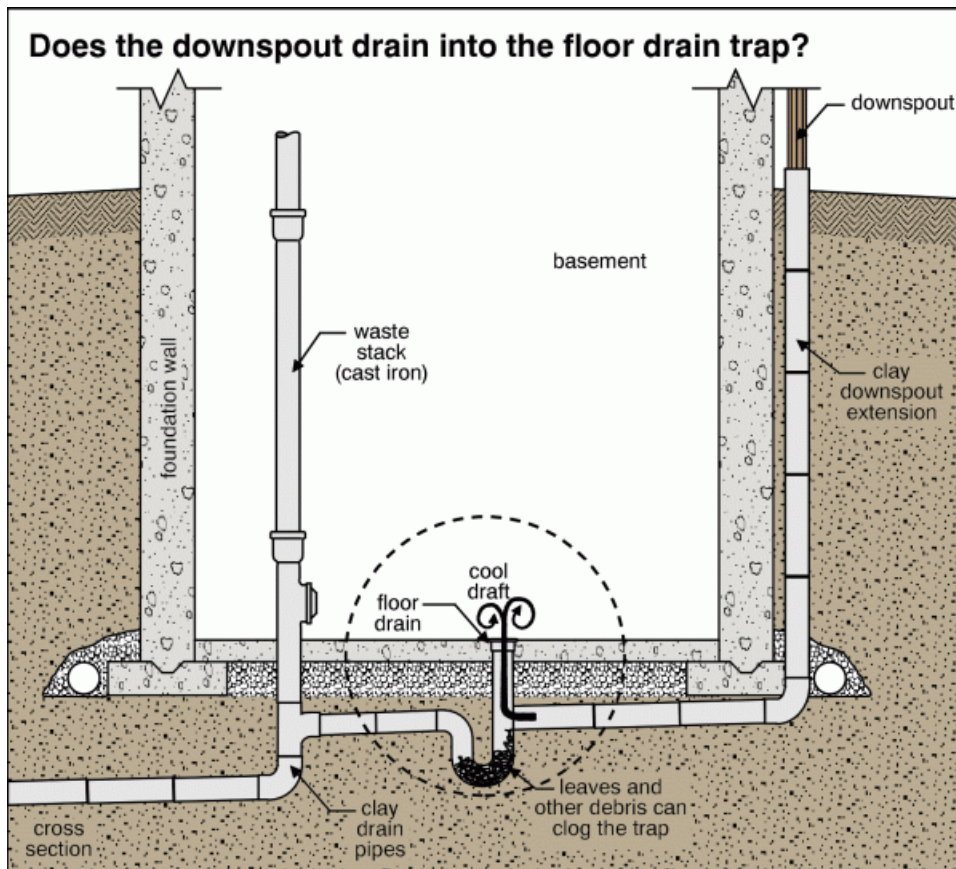
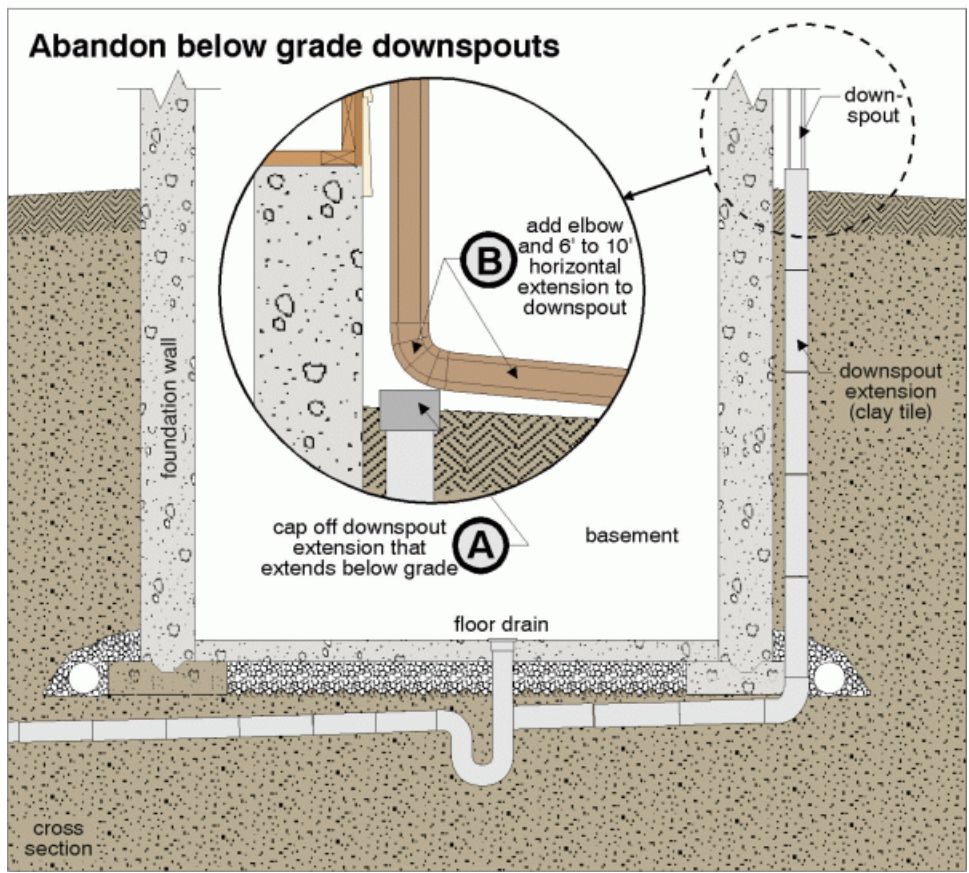
**11. Condition:** • Discharge below grade

**Implication(s):** Chance of water damage to structure, finishes and contents

Unable to find a discharge point away from house, possible it connects to floor drain. Which isn't local building practice. Recommend to disconnect and where possible discharge above ground 6ft away from home onto grass. Otherwise recommend a trench that discharges out to grass/ soil area.

**Task:** recommend further evaluation from plumbing contractor

**Time:** As soon as possible

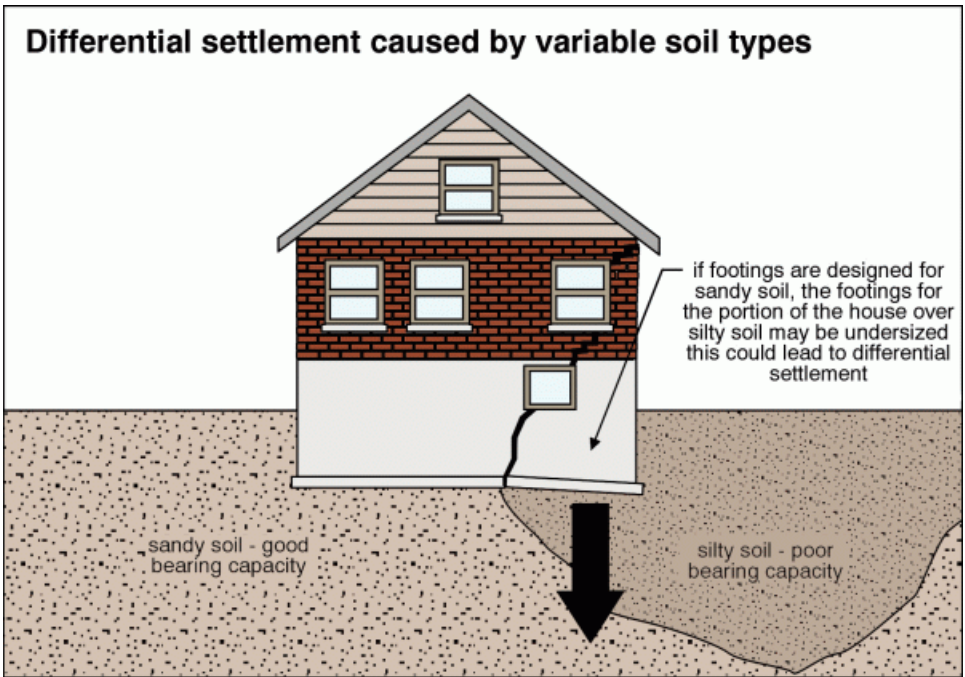
**12. Condition:** • Damage

Structural cracks at multiple points along the rear wall of the house.

15. large crack

**Task:** Further evaluation by Structural engineer

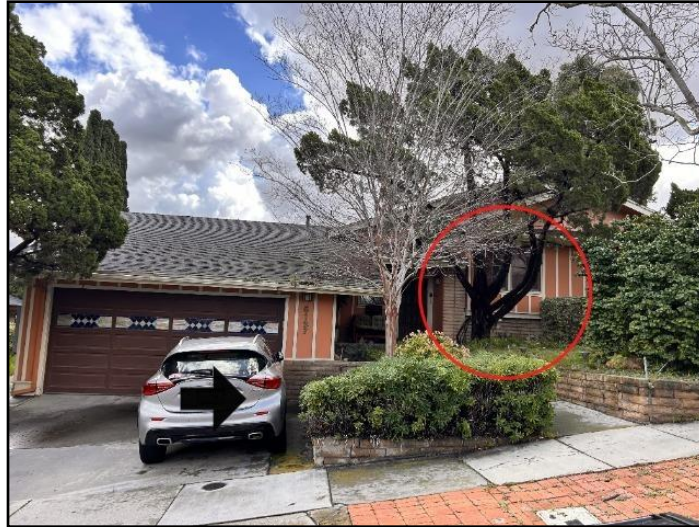
**19. Condition:** • Trees or shrubs too close to building

Trees should be 10 ft away, all other vegetation should be 1 ft away. Therefore they should be removed and overreaching branches should be trimmed regularly to ensure no additional wear accrues.

**Implication(s):** Chance of water damage to structure, finishes and contents | Chance of pests entering building | Material deterioration

24. Trees or shrubs too close to building

**Task:** Improve

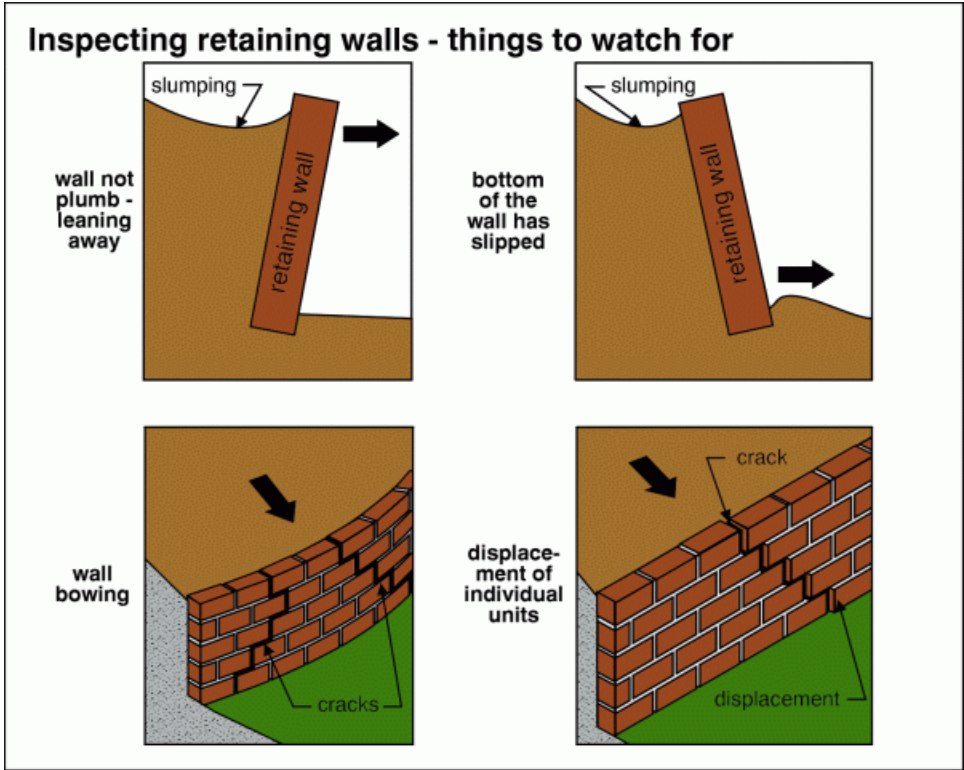
**21. Condition:** • Cracked

Excessive cracks at multiple location along the back.

26. Crackes and slopping away

Task: Further evaluation by landscaping contractor

Time: Immediate

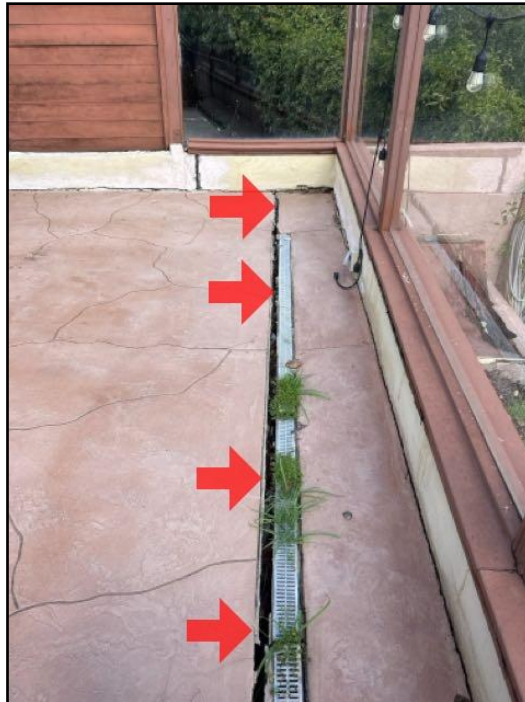
**22. Condition:** • Settling or shifting

29. *Shifting towards the canyon*

**Task:** Further evaluation by landscaping contractor

**Time:** Immediately

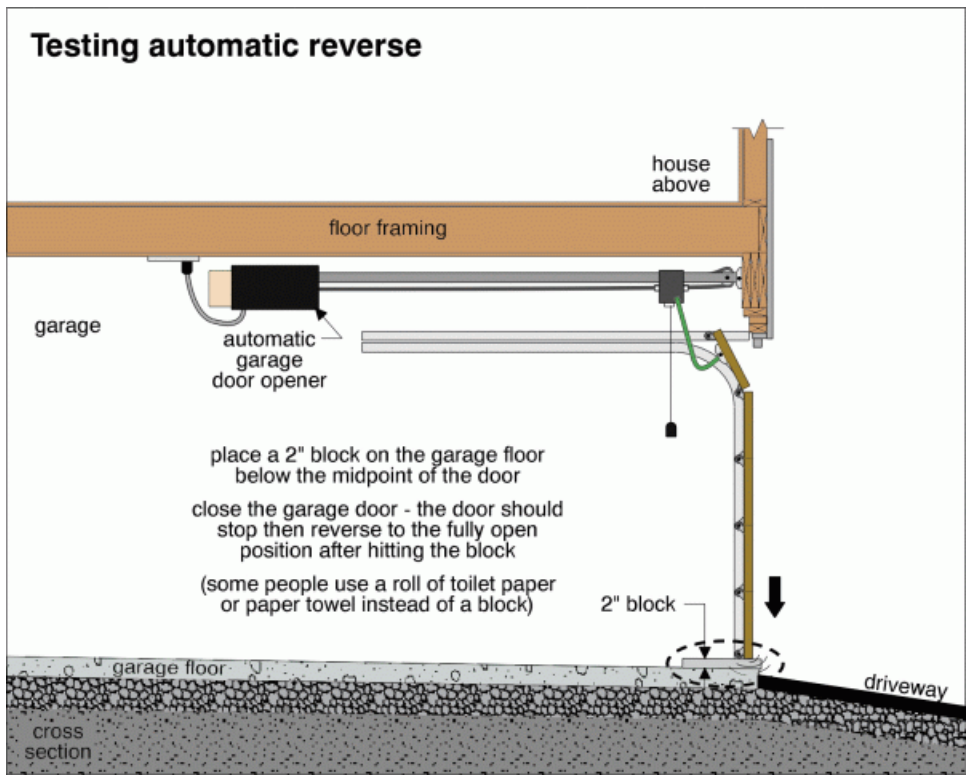
**23. Condition:** • Fails to auto reverse

**Task:** Further evaluation by garage door specialist.

**Time:** As soon as possible

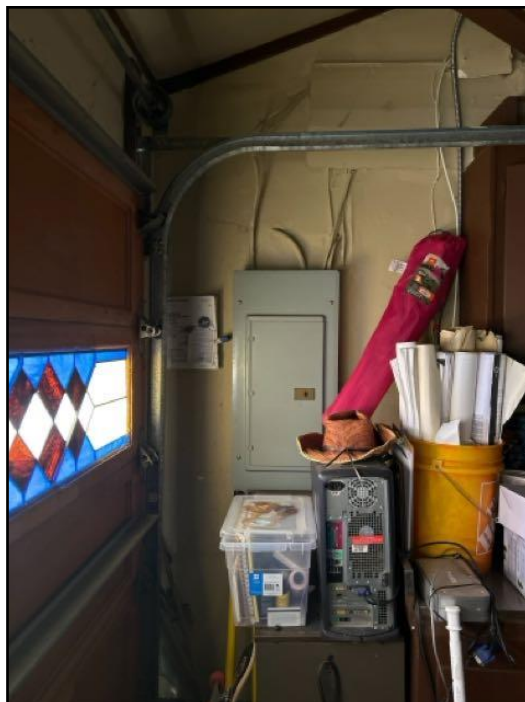
**26. Condition:** • Poor access

32. Breakers - garage

**Task:** Improve

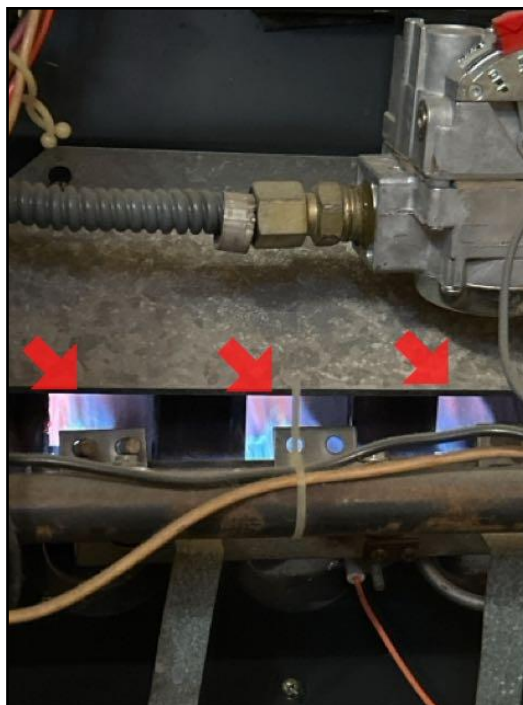
48. Poor flame color or pattern

**Task:** Further evaluation by licensed HVAC contractor

**Time:** As soon as possible

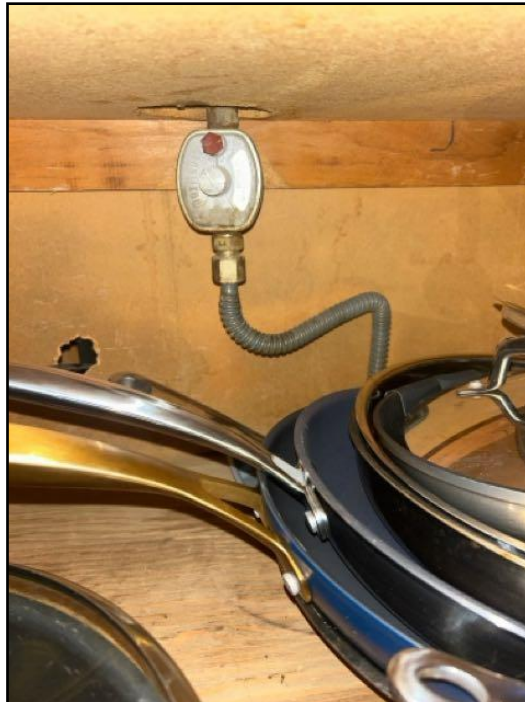
62. Gas shut off valve is not visible

**Task:** Further evaluation by heating contractor.

**Time:** As soon as possible.
